ASCE 41-13 Tier 1 and 2 Seismic Evaluation Report

Kensington Public Safety Building

July 19, 2016

IDA Project Number 1600

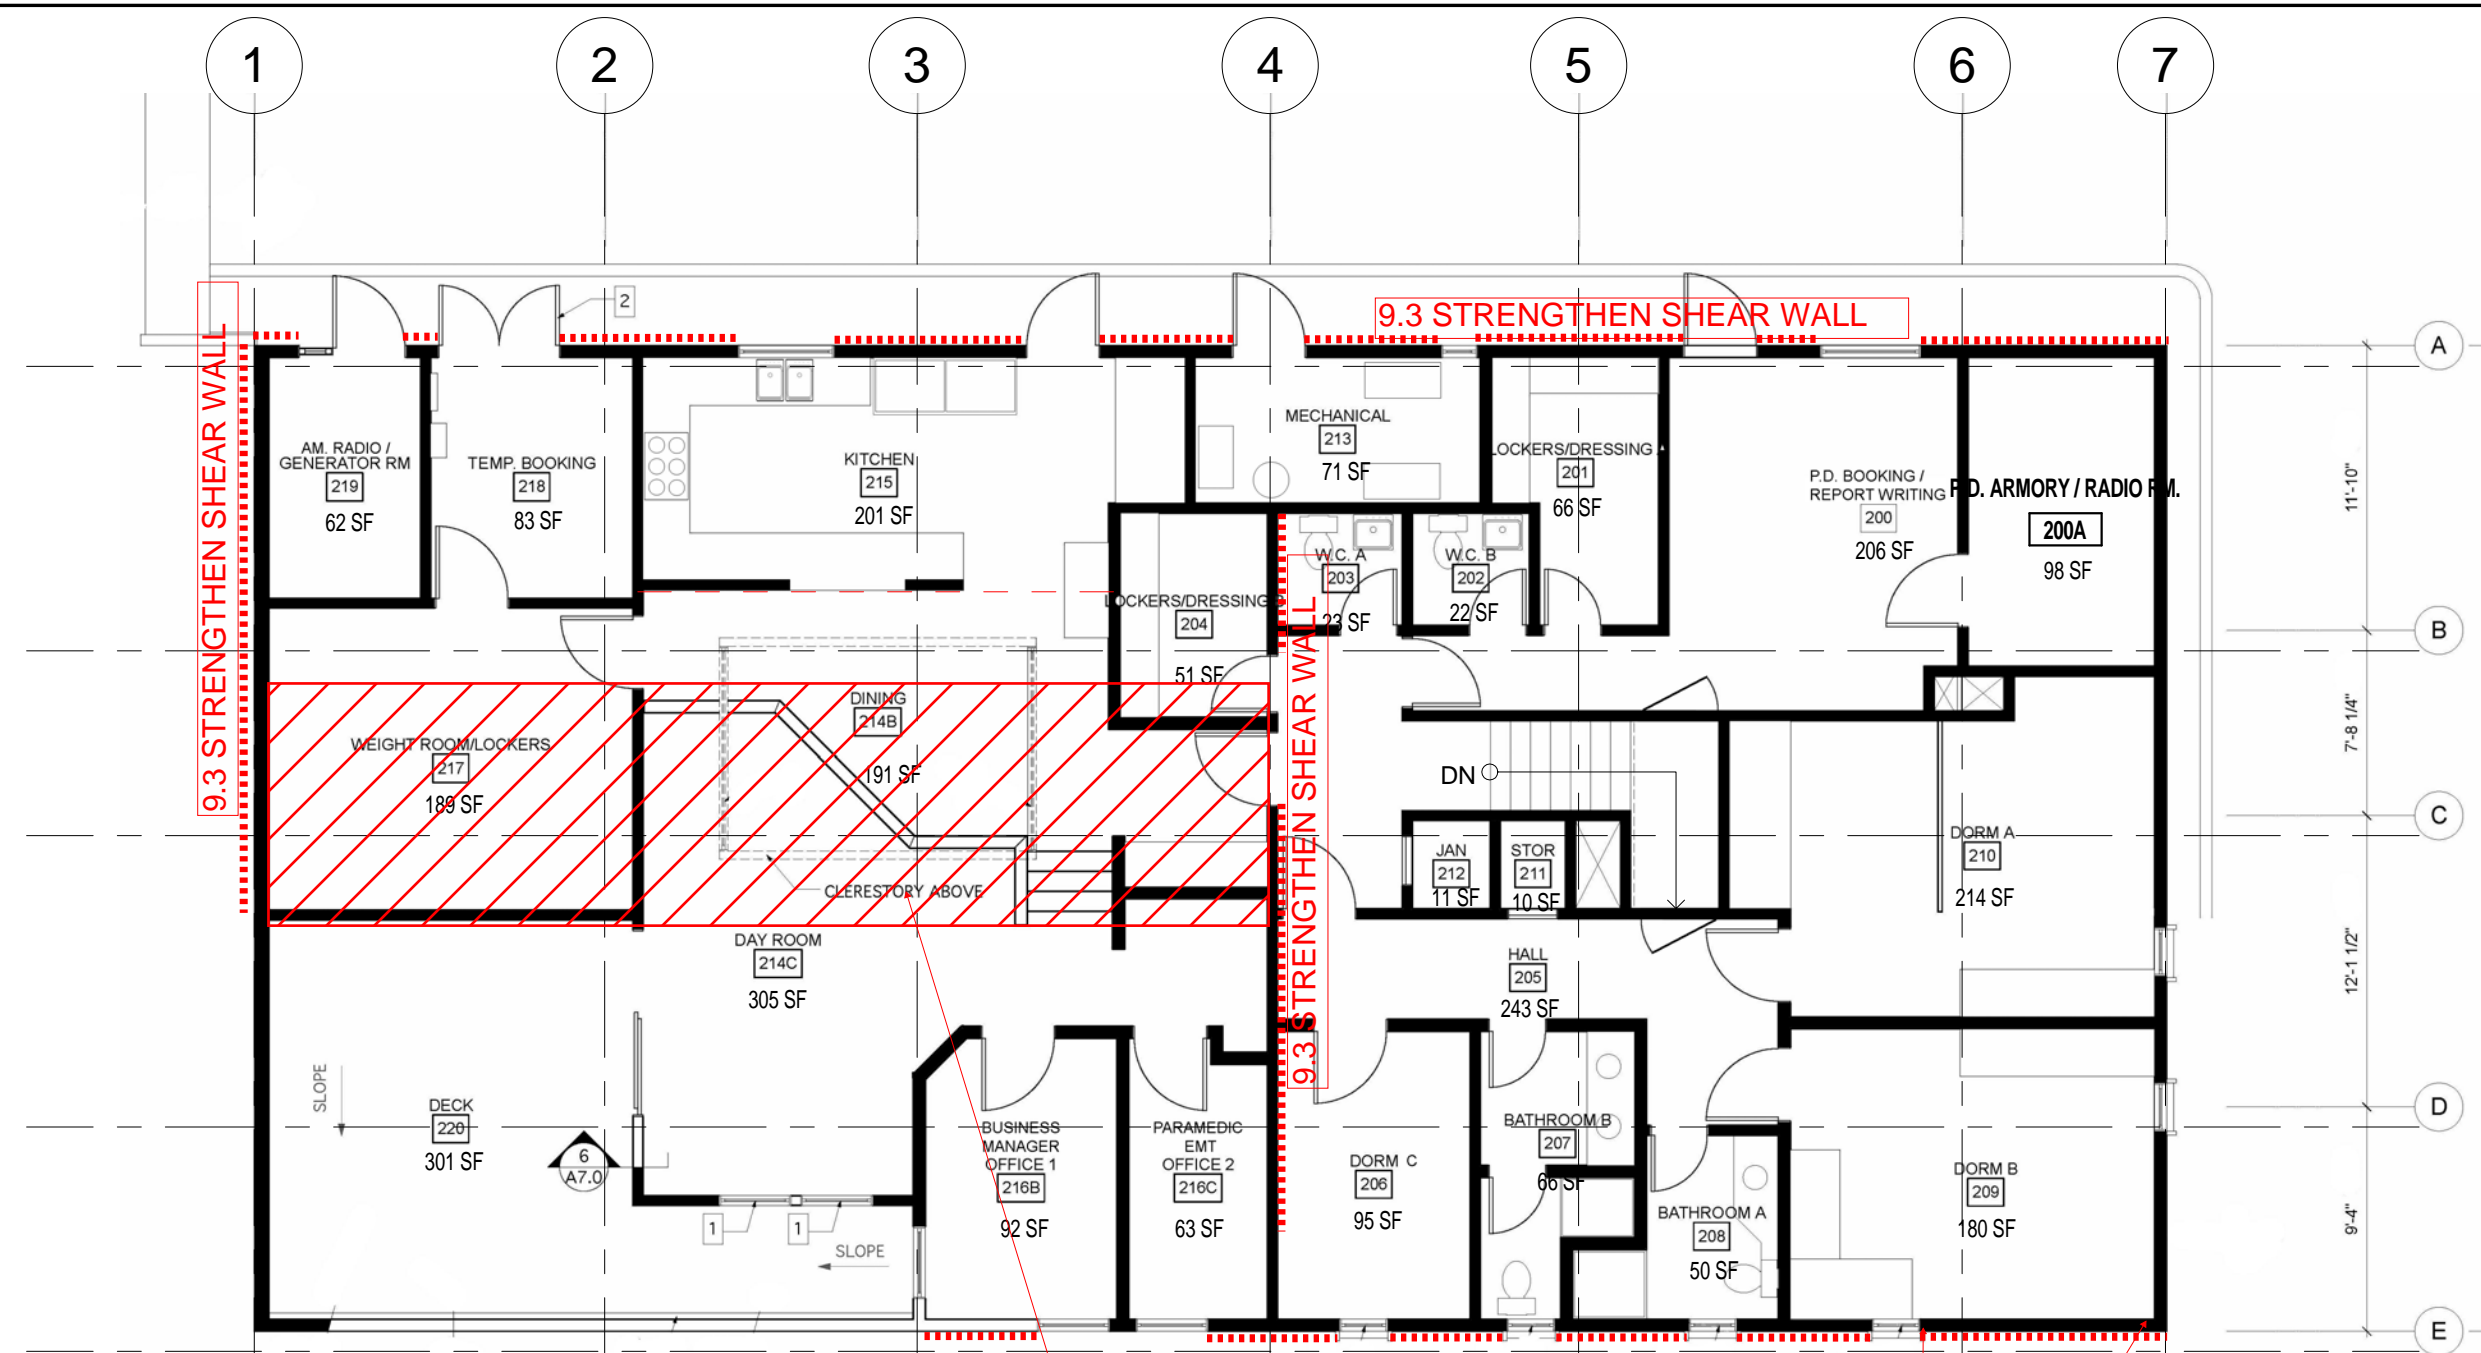
S2
 Drawing No.

A Tier 2 evaluation finds that the collector connections are adequate. The shear wall capacities and moment frame capacities at this line are evaluated further under shear stress checks and moment frame checks. The shear stress check found walls which were not compliant. The moment frame checks for beam and column flexural stresses were compliant. 2nd floor shear walls between grid lines 4 and 7 do not appear to have posts or holdowns to transfer overturning forces to the first floor.

Tier 2 evaluation of the shear walls finds that the shear stress checks are not compliant. The shear stresses in some walls exceed the assumed capacity of the walls. The wall lines which require strengthening are identified in the mitigation plan.

The diaphragm at the second floor has a split level and therefore does not meet the Tier 1 check. Based on evaluation of the diaphragm load path it appears that the diaphragm is insufficient to transfer seismic loads across the discontinuity.

Provide posts and holdowns at the first floor to transfer overturning forces from the 2nd floor shear walls to the first floor.

Add plywood shear walls and holdowns or increase nailing at existing shear walls and replace holdowns as required.

Increase nailing at floor diaphragm and at split level transition to transfer loads across the diaphragm split level.

9.3 STRENGTHEN SHEAR WALL

9.4 STRENGTHEN DIAPHRAGM AND VERTICAL TRANSITION AT SPLIT LEVEL

9.4 PROVIDE HOLDDOWN AND POSTS TO FOUNDATION BELOW TYP AT LINE E
