**ASSESSMENT OF EARTHQUAKE-RELATED
GEOLOGIC/GEOTECHNICAL HAZARDS
AND EXISTING FOUNDATION DISTRESS**

**Kensington Fire Station
Kensington, Contra Costa County, California**

**Kensington Fire Protection District
Kensington, California**

**October 1997
Project No. 4247**

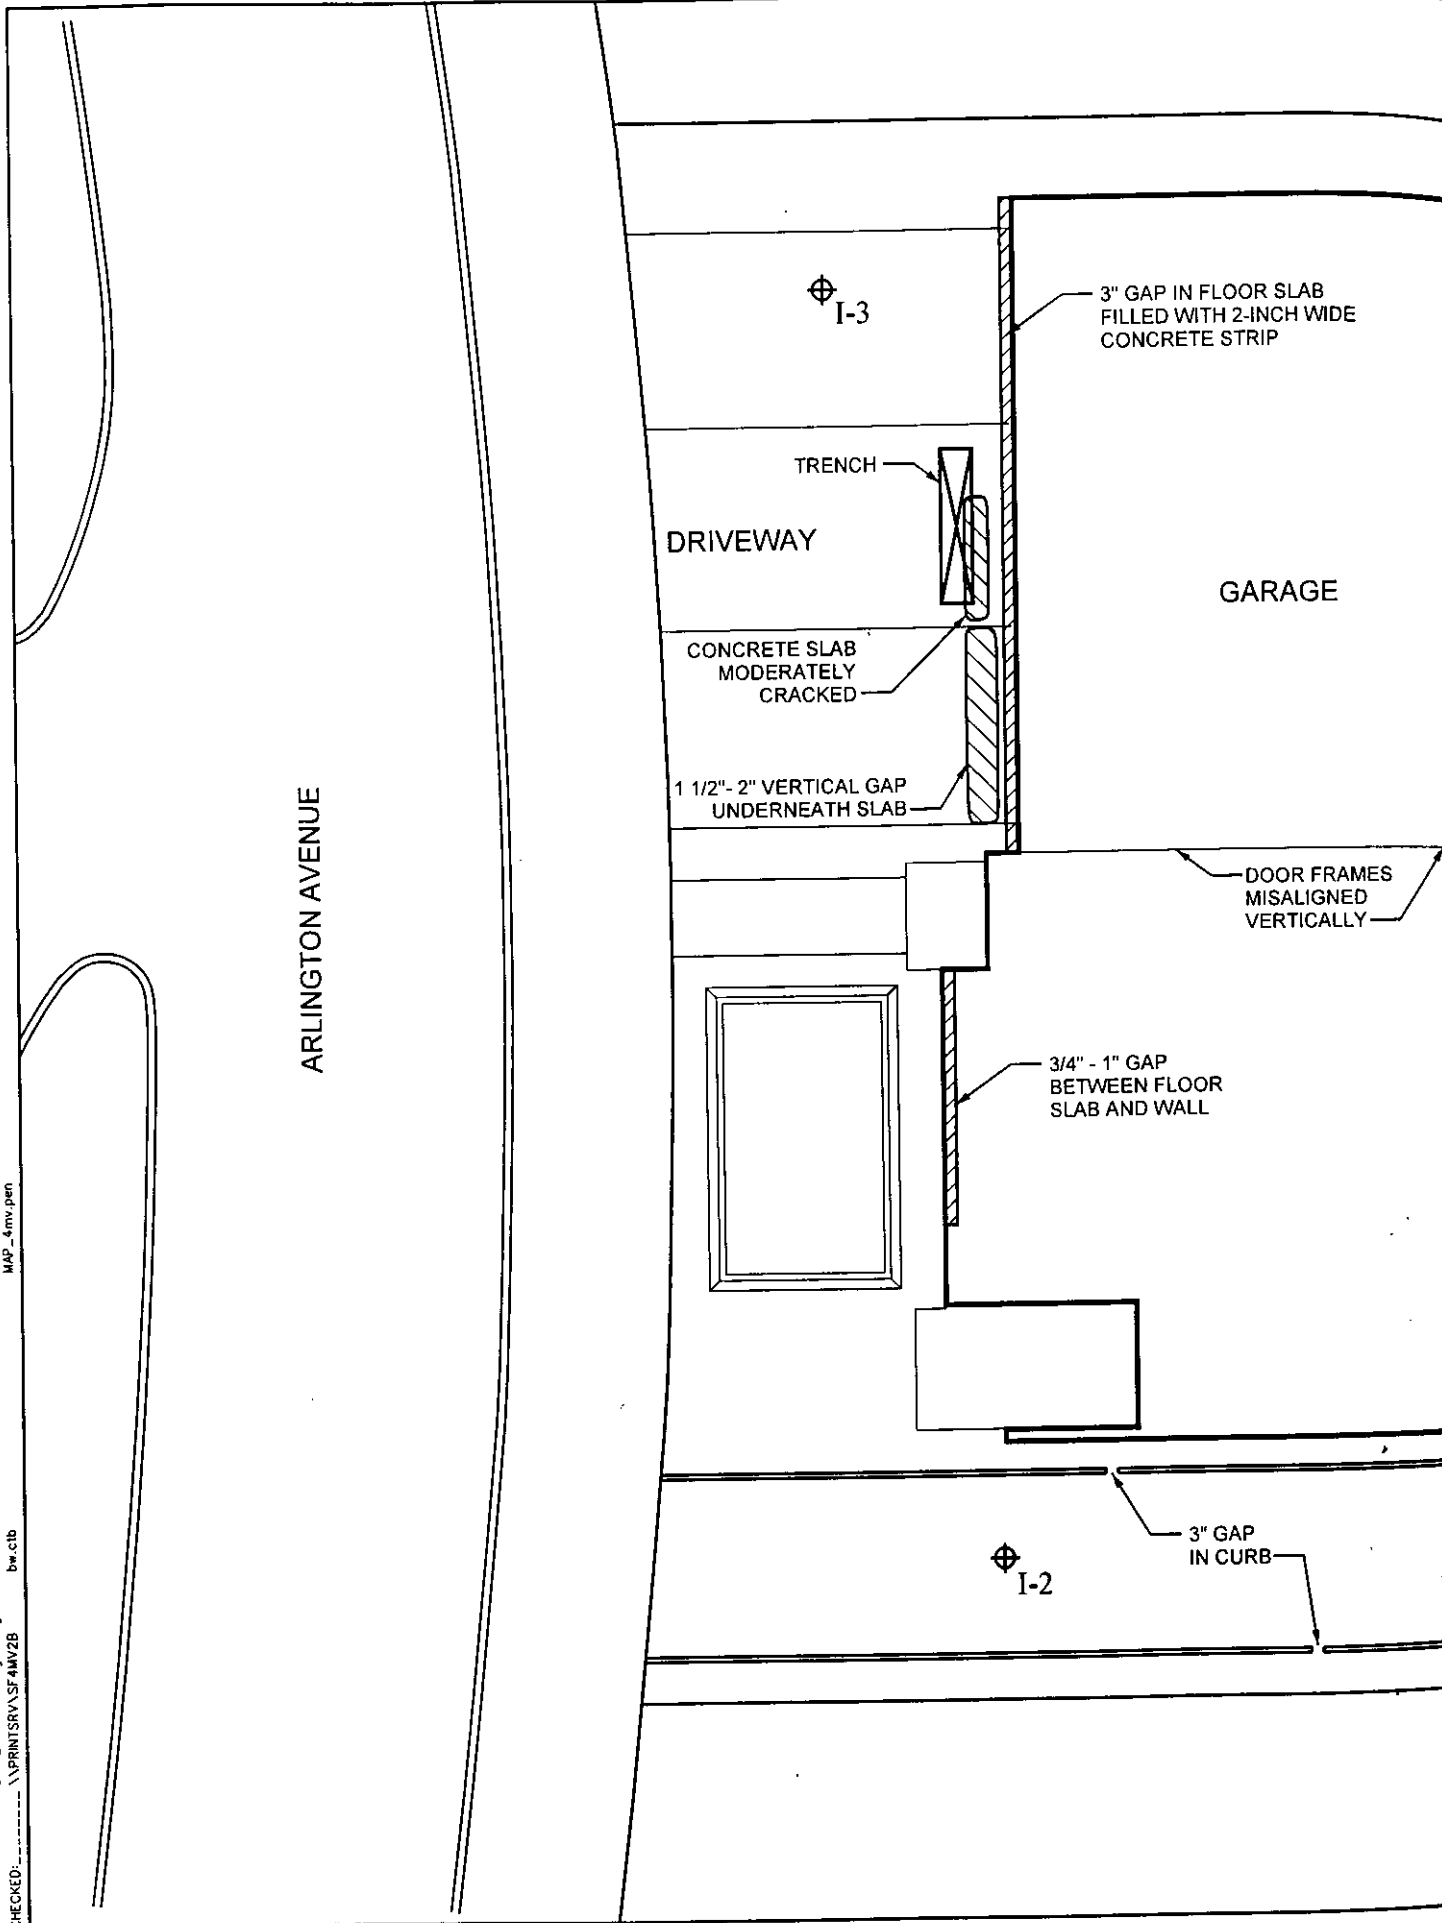
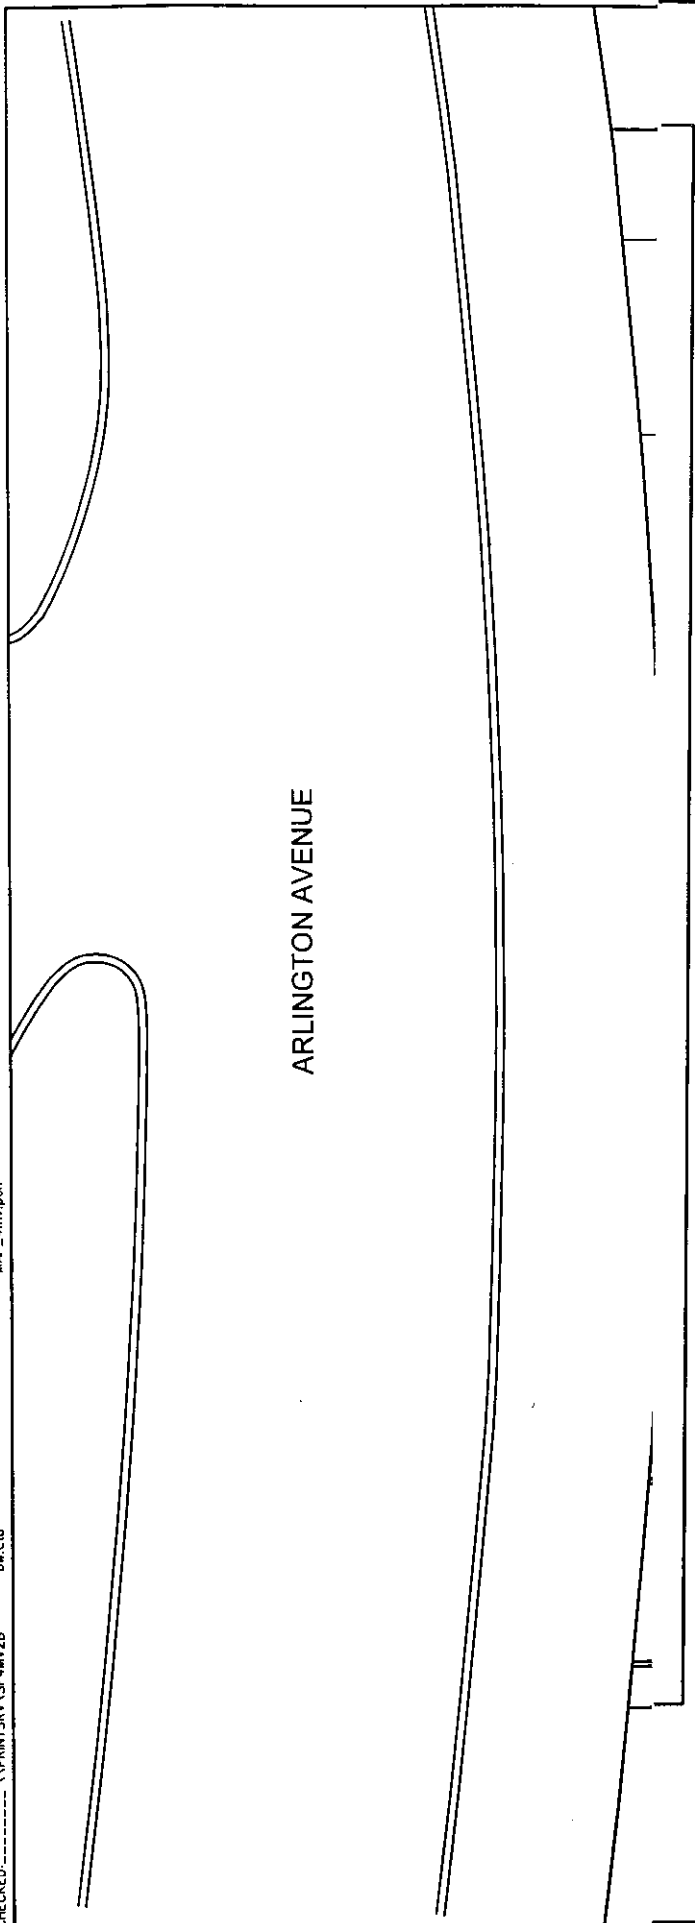
GEOMATRIX	Project No. 4247	Figure 1

- **Foundation distress.** Directly beneath the driveway slab, a 1 to 2 inch void space was observed when we excavated the test pit, which was probably caused by settlement associated with long-term compaction of the apparently medium dense to loose crushed rock and sand fill materials. We are of the opinion, however, that the more pervasive distress being experienced by the Fire Station structure is a result of foundation/footing movements resulting from what we have interpreted to be an on-going slope creep process. We are further of the opinion that the minor subsidence observed in the parking area behind the structure is probably a sympathetic response of the soil/fill in that area to the downslope movements being experienced by the foundations and probably, therefore, to a lesser degree by the structure.

During our field investigation we observed, along the garage front, a relative lateral displacement of about 3 in [75 mm] between the driveway slab and the garage floor, as shown on Figure 1. Reportedly, this gap was filled with 2 in [50 mm] of new concrete about ten years ago. There was also some indication of lateral ground movement on the driveway located on south side of the building, where we observed a 3 in [75 mm] gap on both driveway curbs. However we did not observe any distress pattern in the paved driveway.

floors. We could not inspect the continuous footings, but there was no indication of significant differential settlement. We observed $\frac{3}{4}$ to 1 in [20 to 25 mm] horizontal gaps between the floor slab and the wall in the office area located at the front of the building.

In the paved area behind the building, we observed some localized ground subsidence of about 2 to 3 in [50 to 75 mm], as shown on Figure 1. Furthermore, there was some subsidence along the outer edge of the sidewalk of about 1 to 1½ in [25 to 40 mm].

3" GAP IN FLOOR SLAB
FILLED WITH 2-INCH WIDE
CONCRETE STRIP

CONCRETE SLAB
MODERATELY
CRACKED

In a practical (and economic) sense, there is little that can be implemented to mitigate the on-going slope creep process that has been and will continue to deform the ground at and in the vicinity of the Fire Station site. We are of the opinion, however, that effects of ground deformation on the Fire Station structure may be mitigated by strengthening/stiffening the foundation system. To achieve such strengthening/stiffening, we recommend installing a grid of grade beams beneath the ground-floor slabs to tie the existing continuous footings together, as well as to tie the footing system to the more massive retaining wall foundation at the rear of the structure. It may be prudent, also, to attach the floor slabs to the footings and grade beams; this would further increase the rigidity of the structure foundation system. Such strengthening/stiffening (or increased rigidity) would enable the foundation system to act as a unit to resist and withstand ground deformations, rather than allowing differential footing to footing response, which likely is resulting in the structure distress currently observed that we believe is associated with slope creep. We anticipate that if foundation strengthening/stiffening were to be undertaken, it would occur coincidentally with retrofit of the overall structure.

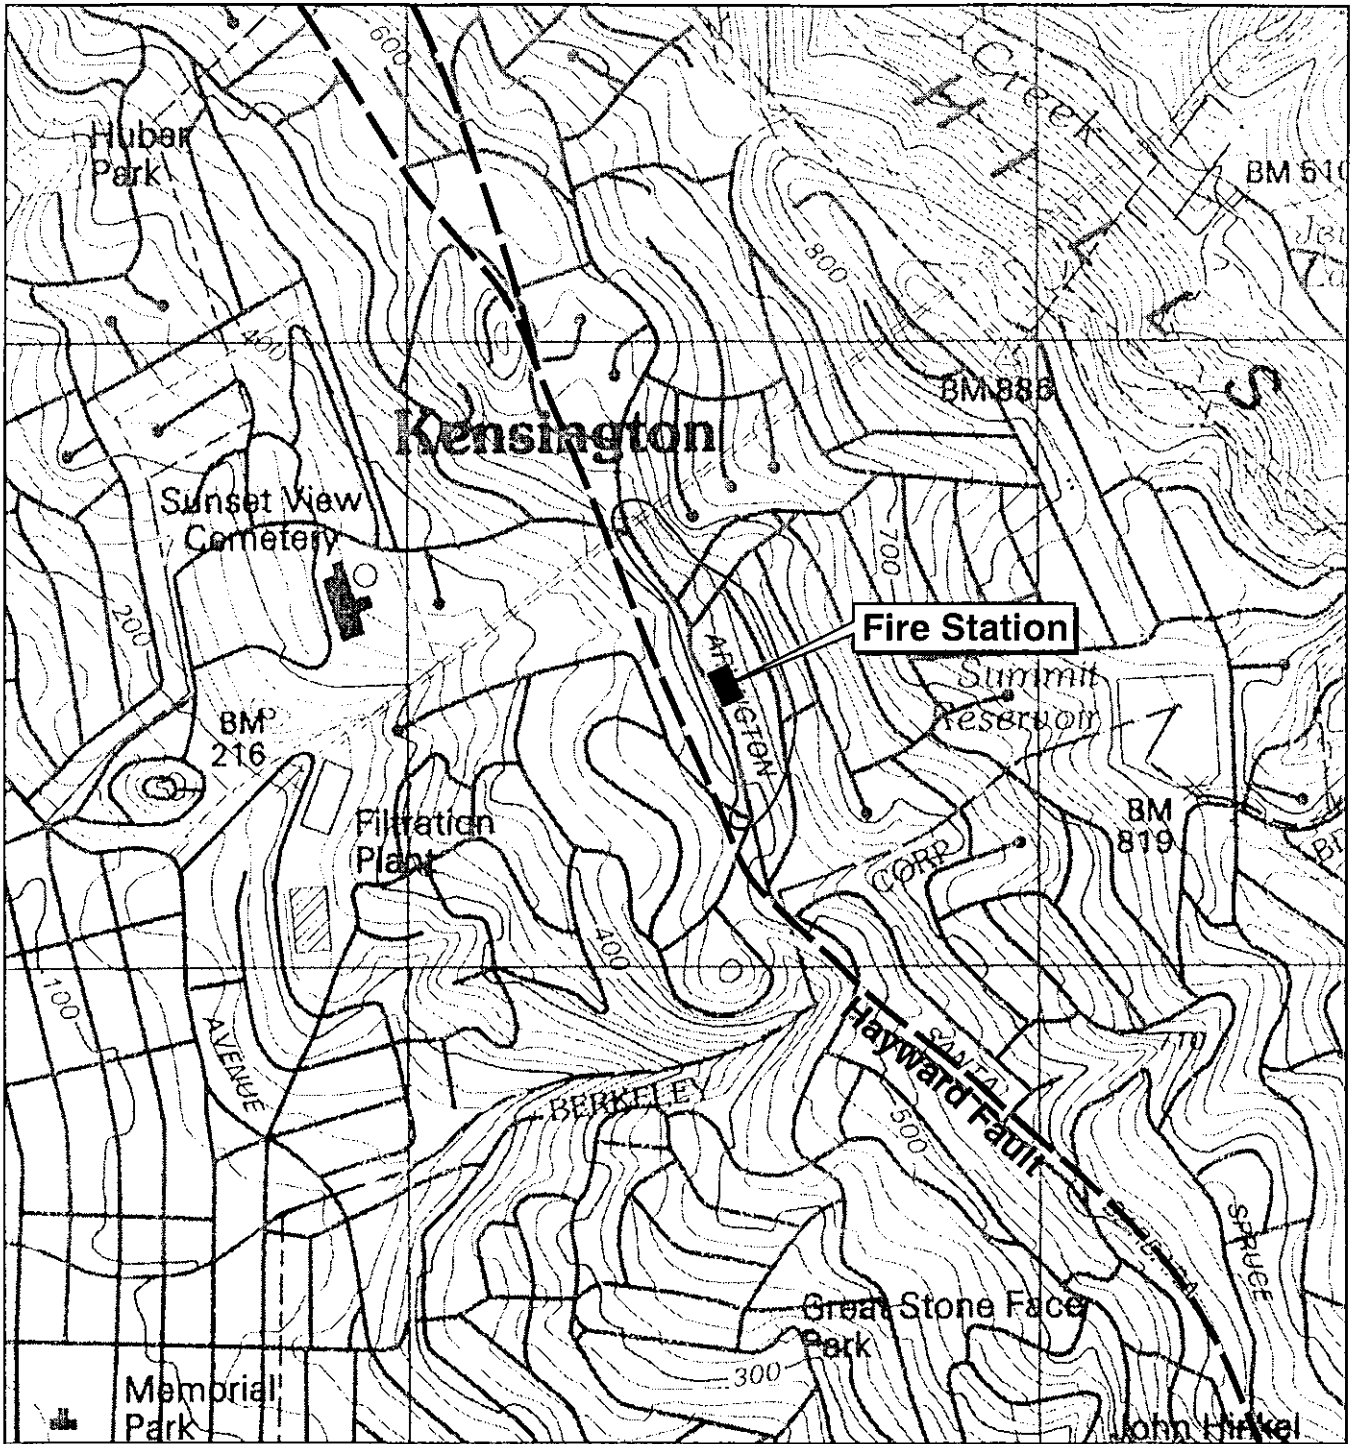
<p>LOCATION OF HAYWARD FAULT AND AREA OF SLOPE CREEP</p> <p>Kensington Fire Station Kensington, California</p>	<p>Figure 2</p>
		<p>Project No. 4247</p>

observed along the Hayward fault in Kensington. Thus, the observed deformation appears to result from westward (down-slope) movement of the near-surface soil and rock. We conclude that slope creep is occurring throughout this zone, and that the observed deformation along or east of Arlington Boulevard likely results from down-slope creep rather than creep on secondary faults. No reconnaissance was completed outside of the zone of slope creep shown on Figure 2.

Area of slope creep, as indicated by observations of cracked and tilted sidewalks, driveways, and staircases. No reconnaissance was conducted outside of the shaded area.

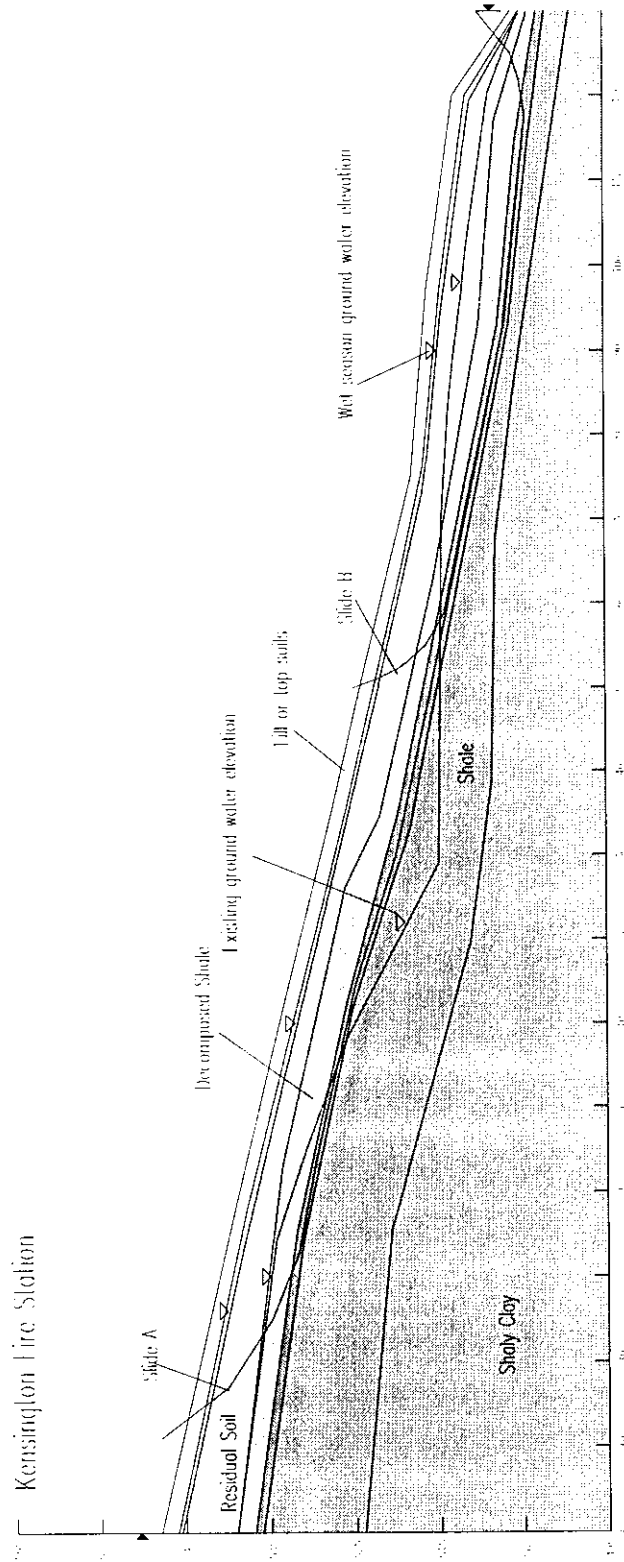
Figure 3 shows an idealized cross-section of the natural slope through the Kensington Fire Station site. The slope stability model suggests that the majority of ground deformation at the site occurs along an interface between the decomposed shale and shale deposits. Static factors of safety of two potential sliding surfaces (indicated on Figure 3 as slides A and B) were calculated assuming two ground water conditions. The two ground water elevations represent the conditions of the ground water during the dry (present) and wet seasons. For the dry ground water condition, factors of safety in the 1½ to 2 range were calculated. Factors of safety for the wet ground condition, however, were calculated to be only slightly greater than unity (i.e., about 1.1 to 1.2). These results indicate that the sloping ground at and in the vicinity of the Fire Station is generally stable under gravity (static) loading for the lower groundwater conditions prevalent during drier seasons of the year; however, as groundwater rises in wetter seasons, the slope becomes marginally stable and prone to creeping of the surficial soil deposits.
