HALEY & ALDRICH, INC.
2033 N. Main Street
Suite 309
Walnut Creek, CA 94569
925.949.1012

18 January 2022
File No. 201747-000

Subject: Floor Survey
Kensington Public Safety Building
217 Arlington Avenue
Kensington, California

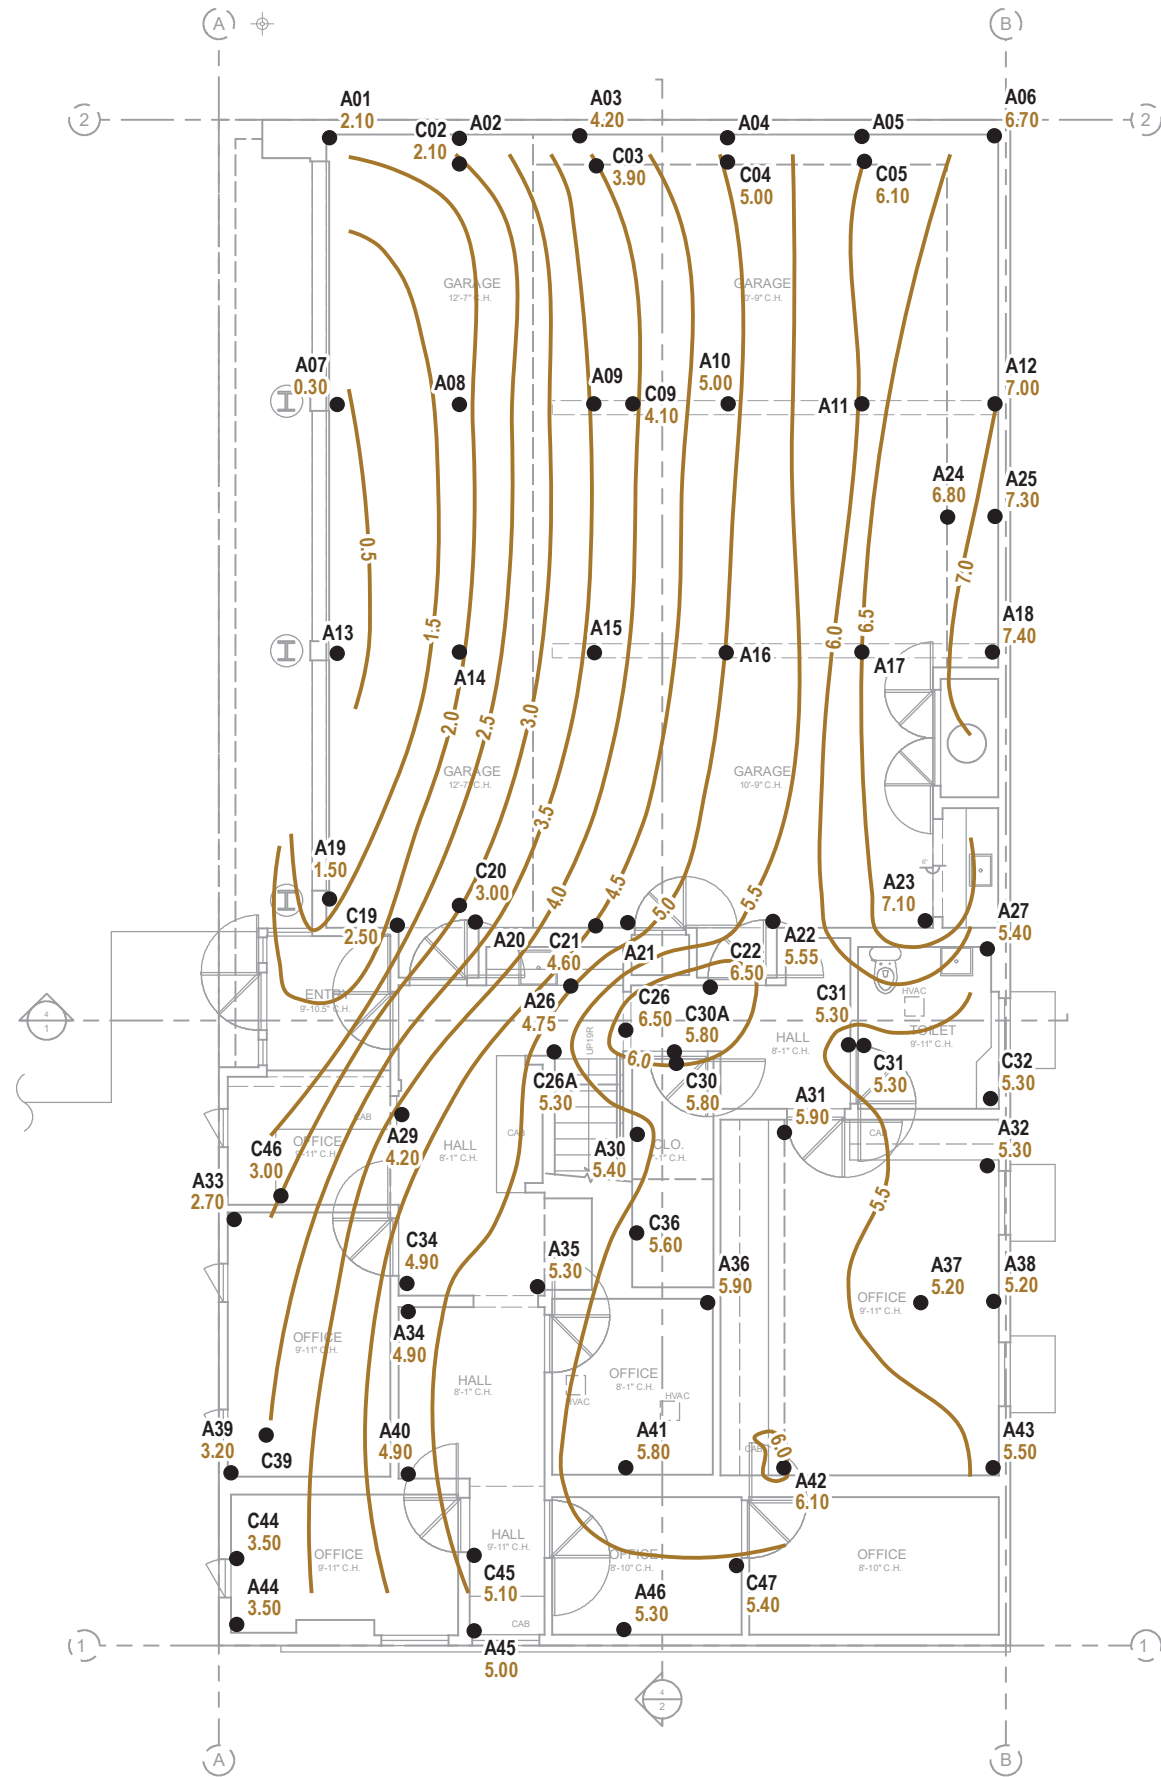
FIGURE 2

A total of 139 floor survey points were designated for topographic measurements by Haley & Aldrich and ZFA at locations throughout the first floor and second floor of the existing structure interior. The survey of both floors was performed on 12 November 2021. The topographic measurements were collected using a PRO-LEVEL Manometer (water-level), which reports relative elevation measurements of floor levels at discrete locations. Figures 2 and 3 show the survey points on both first and second floor. The relative elevation differences of the survey points adjusted according to the base points on both floors are summarized in tabular format on the attached Table 1 – Manometer Readings.

**FLOOR ELEVATION SURVEY
 FIRST FLOOR**

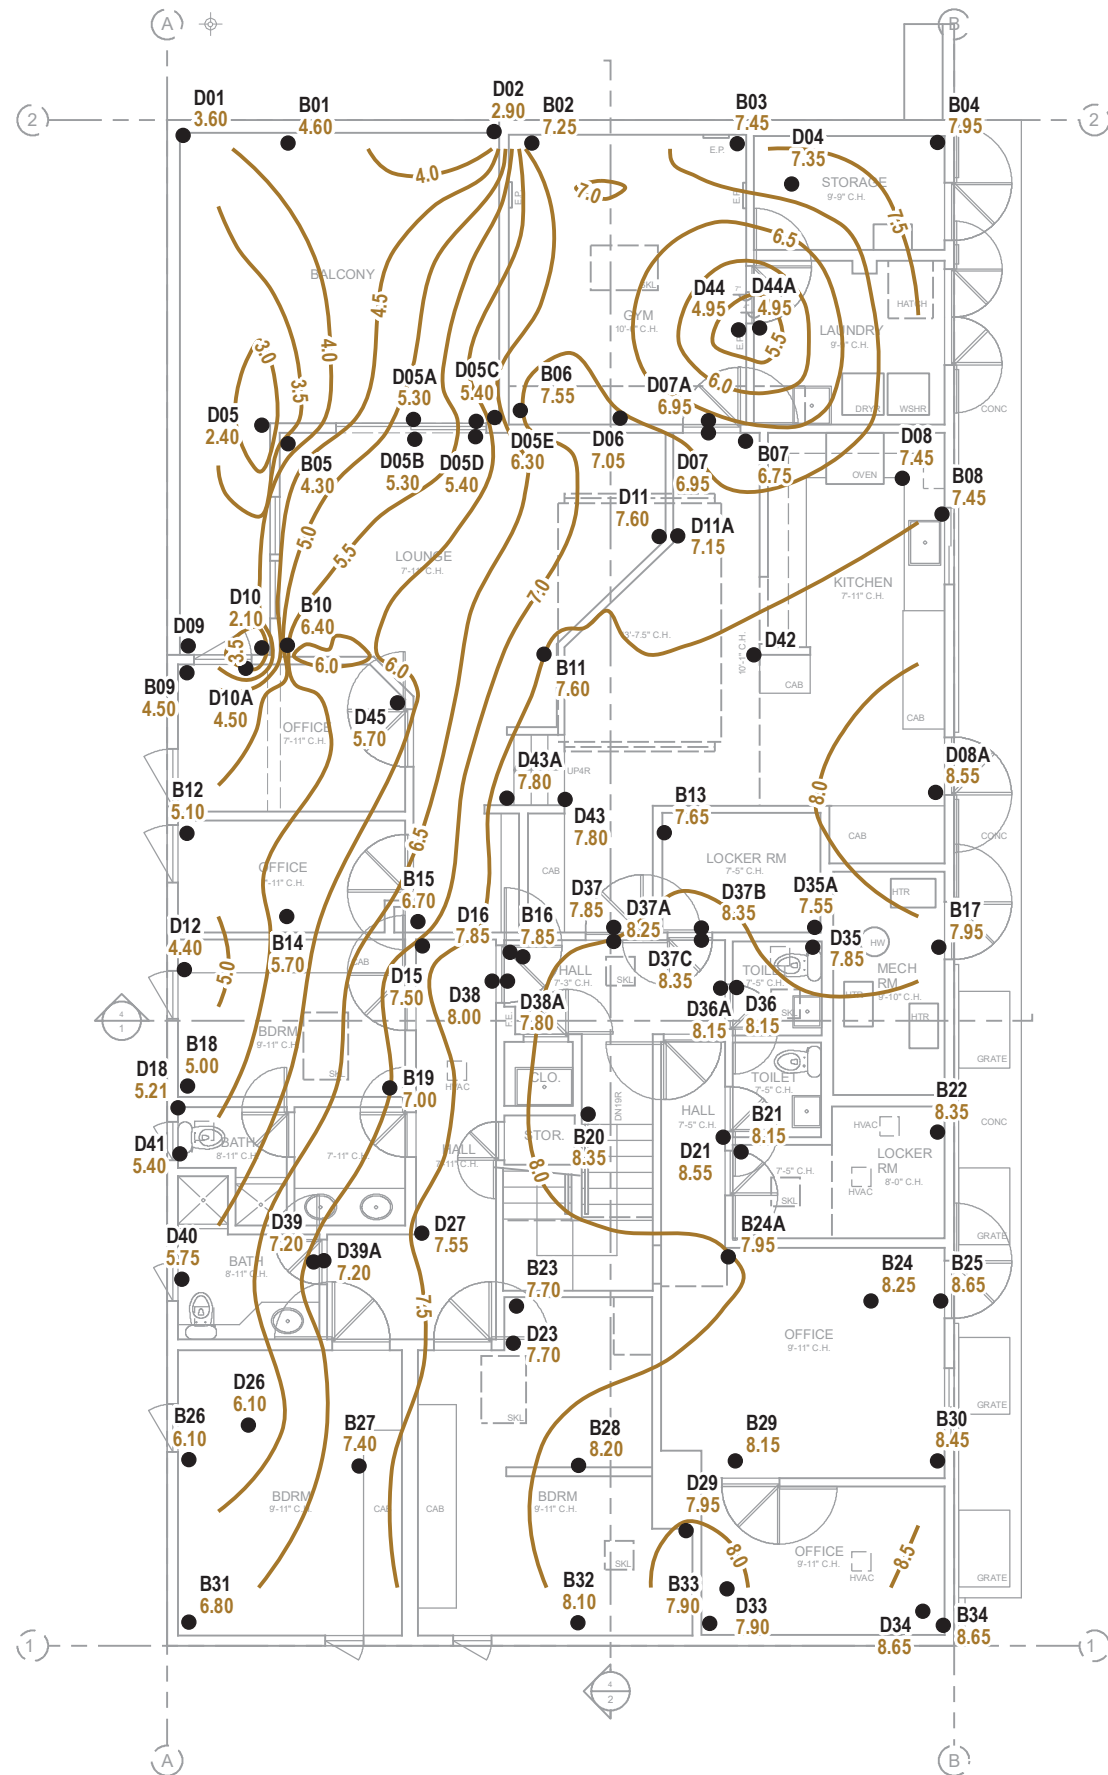
FIGURE 3

**FLOOR ELEVATION SURVEY
 SECOND FLOOR**
