kensington public safety building

▪ board of directors meeting

september 11, 2019

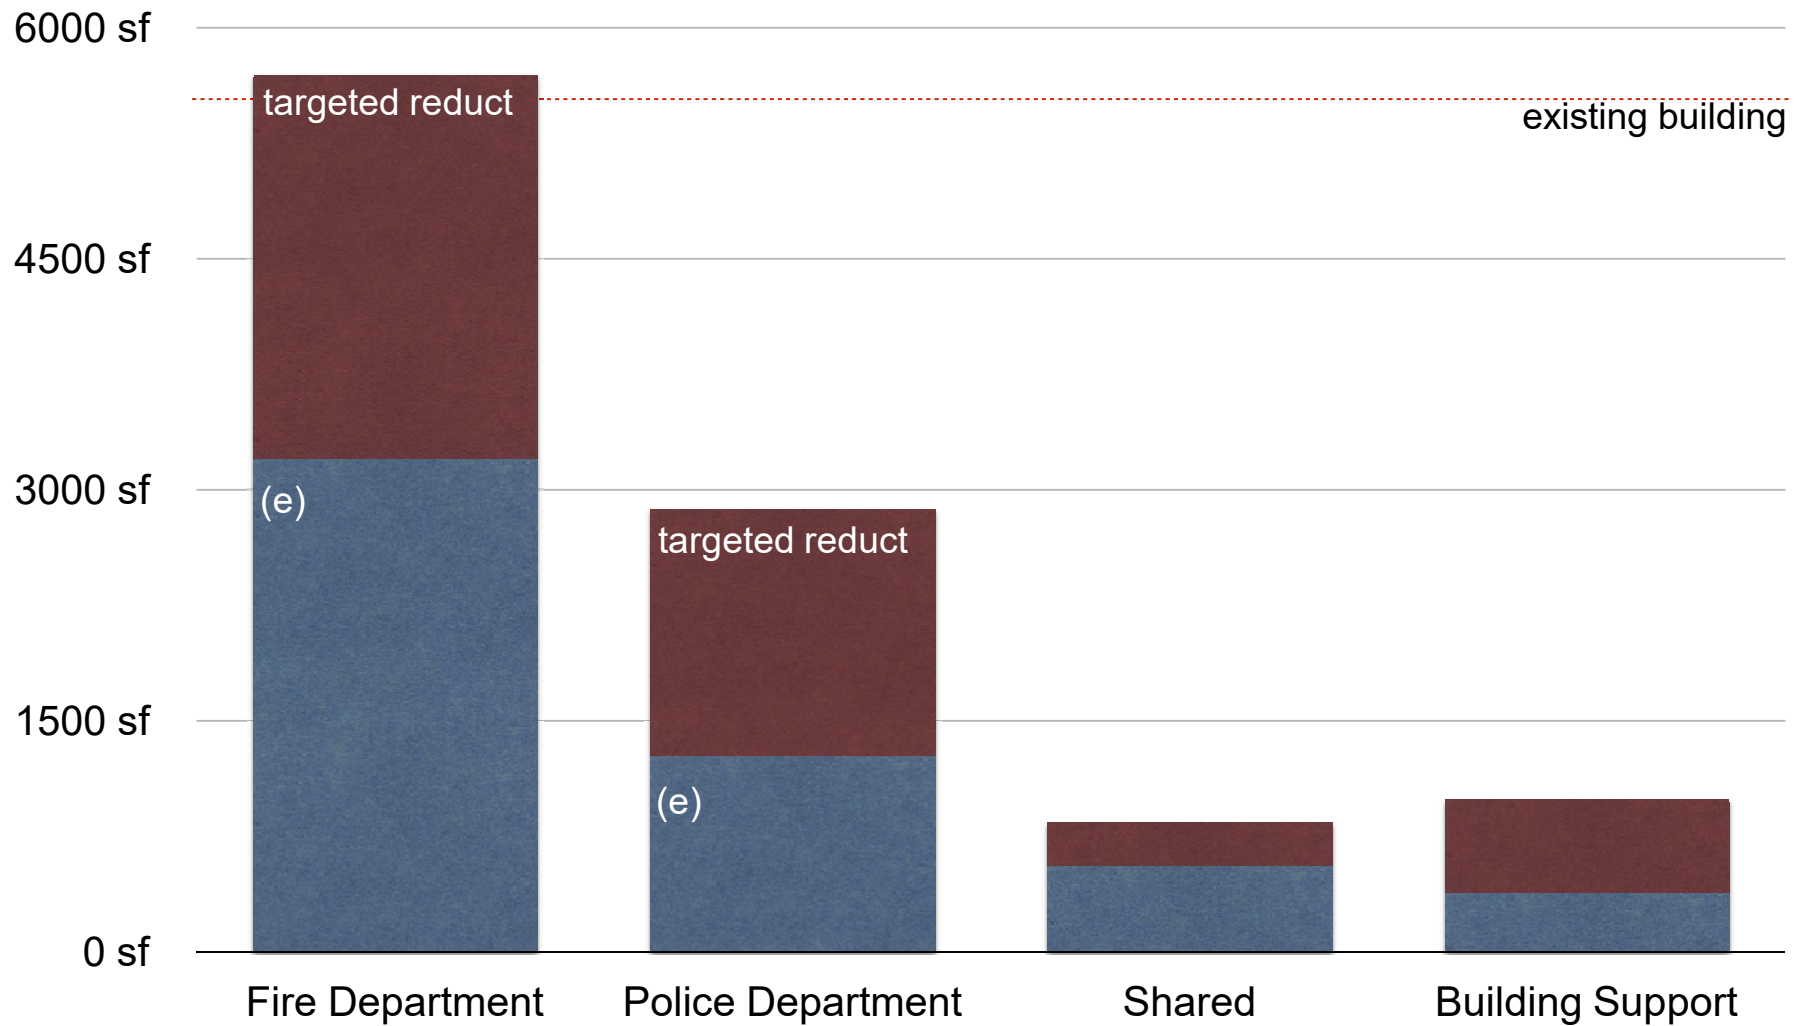
Existing vs. Targeted Reduction Program Areas
