**ASSESSMENT OF EARTHQUAKE-RELATED
GEOLOGIC/GEOTECHNICAL HAZARDS
AND EXISTING FOUNDATION DISTRESS**

**Kensington Fire Station
Kensington, Contra Costa County, California**

**Kensington Fire Protection District
Kensington, California**

**October 1997
Project No. 4247**

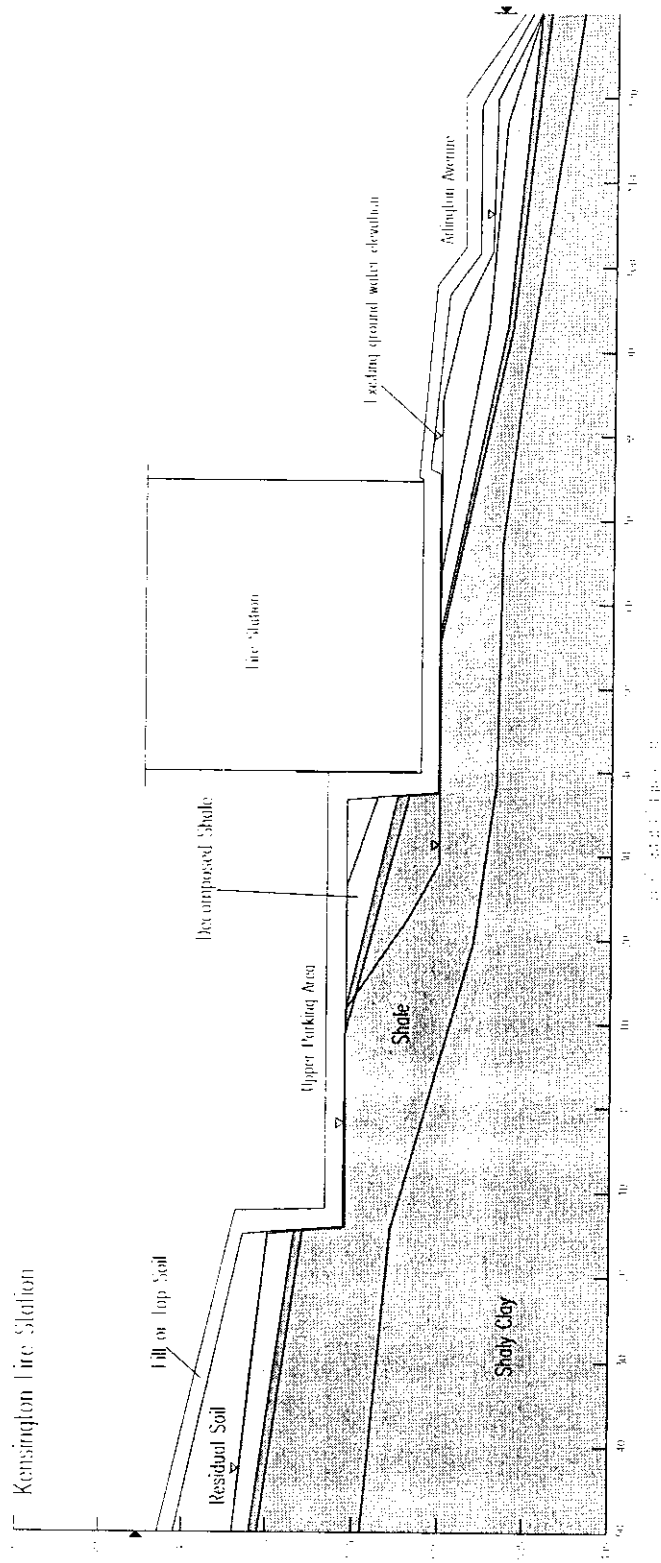
Figure
 4
 Project No.
 4247

LOCATION OF SITE FEATURES ON SLOPE CROSS-SECTION
 Kensington Fire Station
 Kensington, California
